Asbestos and Lead-Based Paint Survey Report

Building M766
Hospital District – Old Navy Base
North Charleston, South Carolina

February 3, 2020
Terracon Project No. EN197470

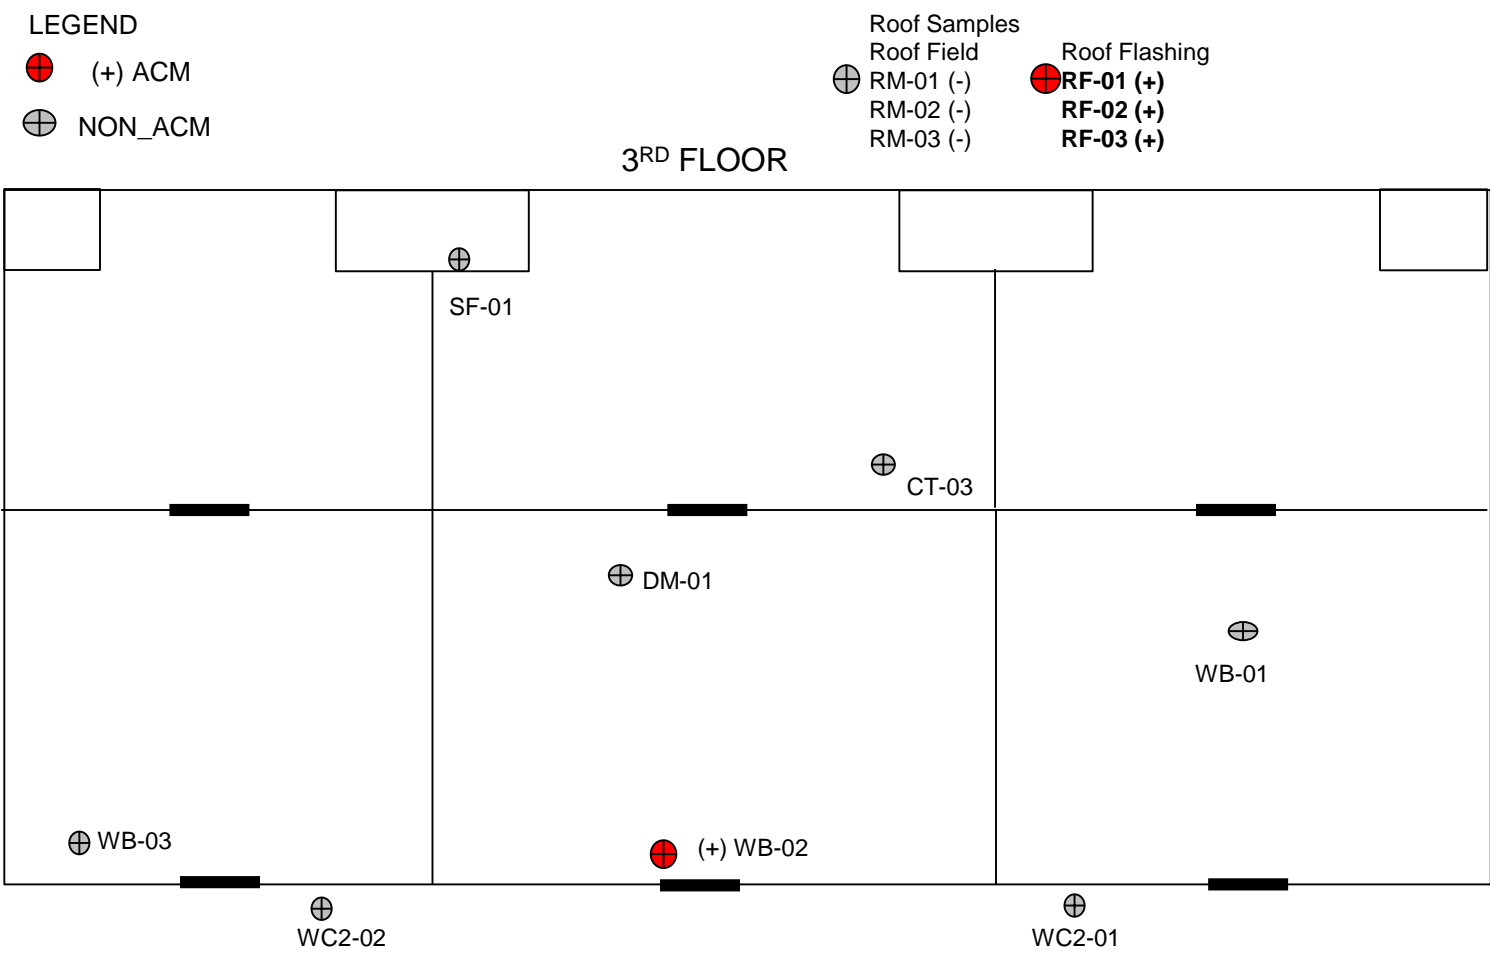
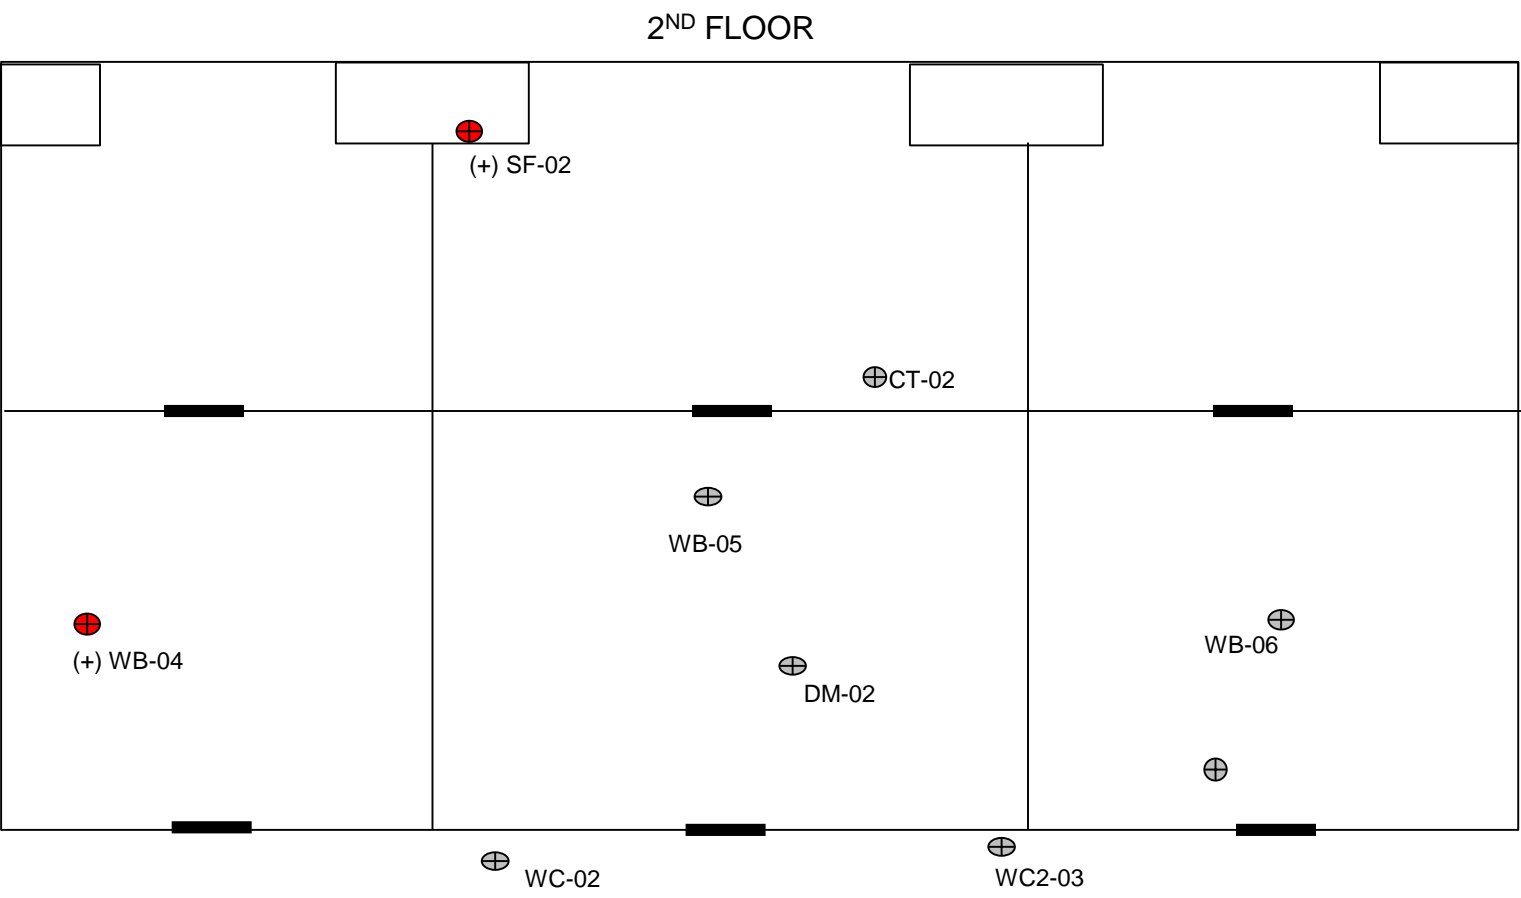
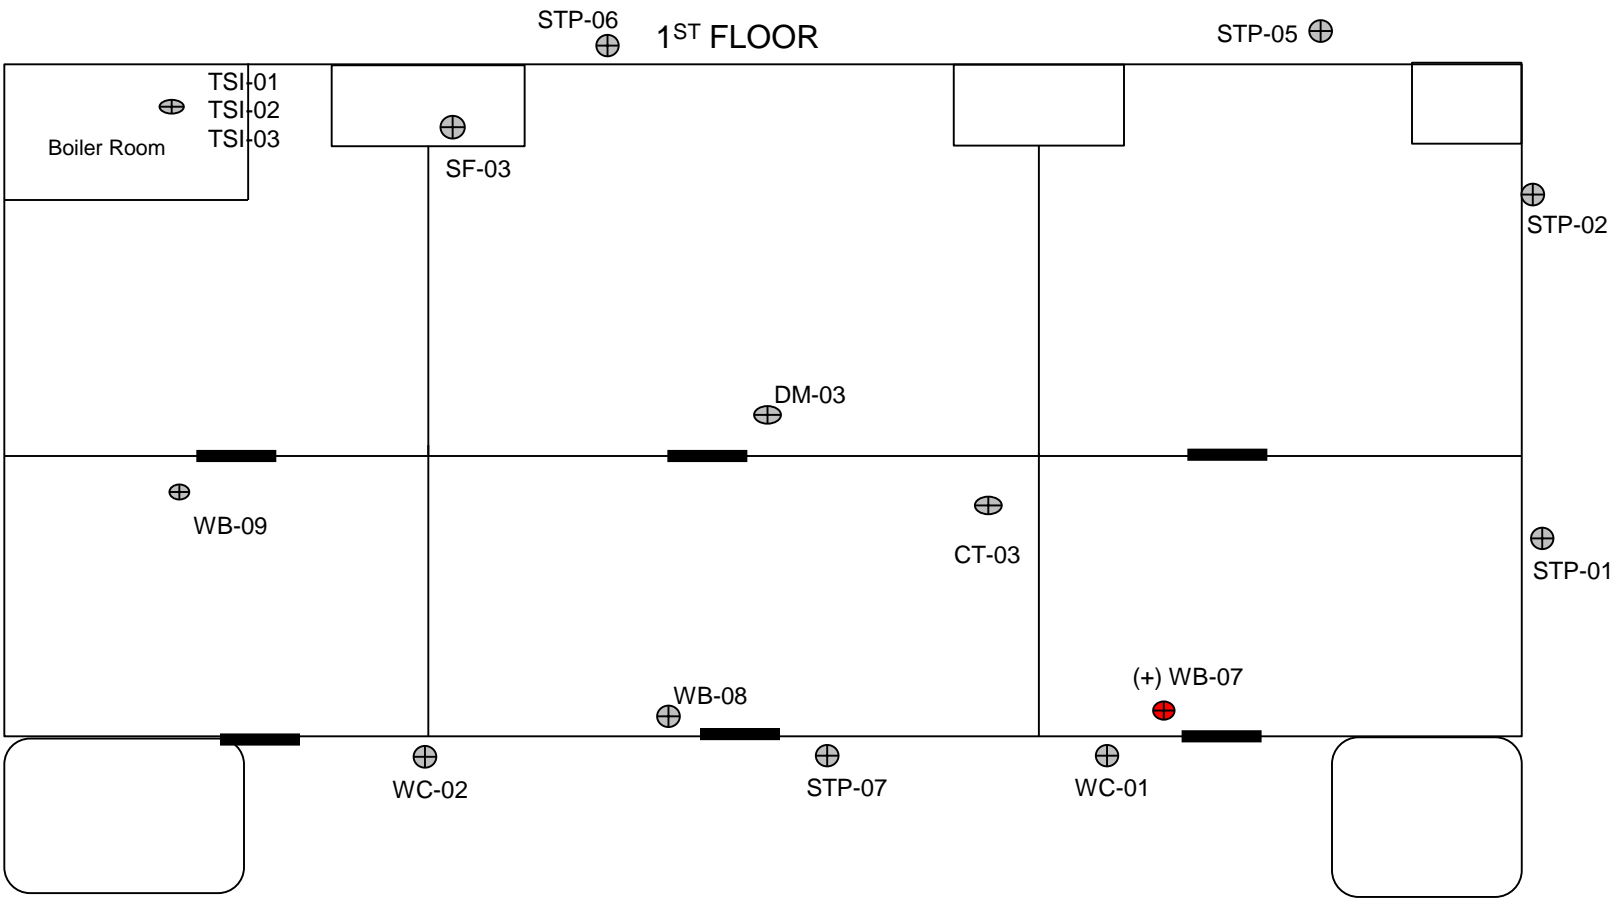
SITE DIAGRAM WITH SAMPLE LOCATIONS

A summary of the suspect ACM samples collected during the survey is presented in Table 1 in Appendix A. Sample locations are depicted on a Figure A-1 in Appendix B.
